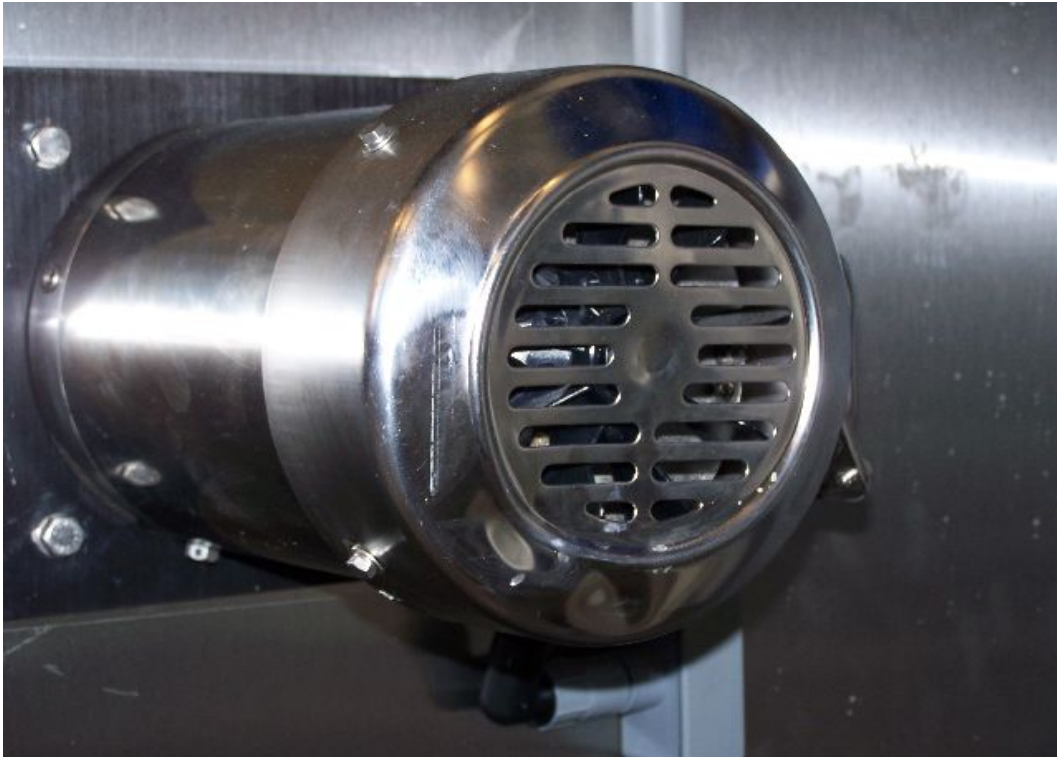
Picture Number: 2 of 4 For CPFC Pro #: VF112345

Aluminum Fan Motor Cover, Part Number 89222, Serial Number 020609X1433 packaged in a single wall corrugated carton. The outer carton was dented in the lower right hand corner. The internal packaging showed no visible damage. Item was dented along the lower right side causing the grates adjacent to the dent to come in contact with the fan blades. The damage corresponds to the dent in the outer carton. I was told by the plant supervisor, Joe Smith, that box was delivered to its current location via a fork truck. Joe was unable to determine whether or not repairs would be possible at this facility.
